**Flood Control Project Maintenance  
Levee Inspections****LMA District Cover Sheet****Spring 2012 Levee Inspection Results****Sutter Maintenance Yard Maintenance Area 0016**

**Levee Inspection Report By Mile - Spring 2012**

**Sutter Maintenance Yard Maintenance Area 0016**

Waterway					Bank	Unit Miles	Inspection Start/End		Inspector
Unit No. 01 Feather River					Right	4.09	03/28/2012 03/28/2012		Clay Thomas
LMR No.	Levee Mile		Category	Item	Location * + Rating	Action/Comment	GPS Latitude/Longitude		Issue No.
	Start	End					Start	End	Photo
1	0.00	4.05	Earthen Levee	Vegetation	LS A/W Ma	V1 : Control annual grass and weeds on the levee slopes and easements.	39.255886 ° -121.636399 °	39.310793 ° -121.637689 °	3
DWR ID: DWR_MA0016_01_s_2012_3									
2	0.00	4.05	Earthen Levee	Vegetation	WSA/W Ma	V1 : Control annual grass and weeds on the levee slopes and easements.	39.255886 ° -121.636398 °	39.310793 ° -121.637689 °	4
DWR ID: DWR_MA0016_01_s_2012_4									
3	0.01	0.01	Earthen Levee	Animal Control	LS C Ma	A3 : No rodents visible, but rodent burrows visible; need to backfill and compact or grout burrows.	39.255875 ° -121.636398 °	39.255983 ° -121.636417 °	1
DWR ID: DWR_MA0016_01_s_2

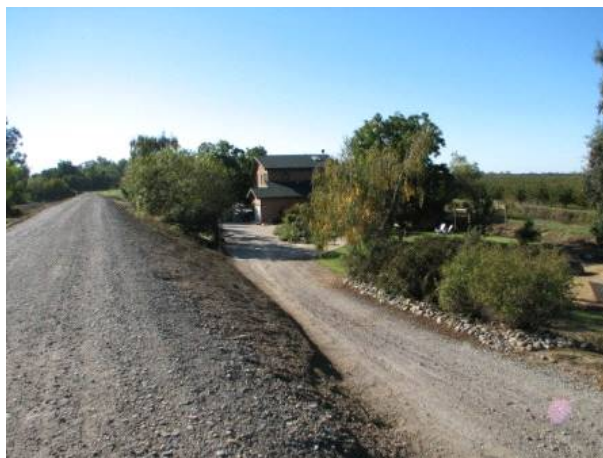
Levee Mile Report Line	4
Start Levee Mile	0.06
End Levee Mile	0.10
Location	Land Side
Category	Earthen Levee
Item	Vegetation

4	0.06	0.10	Earthen Levee	Vegetation	LS M En	V6 : Landscaping	39.256618 ° -121.636442 °	39.257228 ° -121.636462 °	2 Y
DWR ID: DWR_MA0016_01_s_2012_2									
5	0.18	0.18	Earthen Levee	Encroachments	LS M En	BU : Buildings	39.258437 ° -121.636613 °	39.258437 ° -121.636613 °	15 Y
DWR ID: DWR_MA0016_01_s_2012_15									
6	0.39	0.39	Earthen Levee	Animal Control	LS M Ma	A3 : No rodents visible, but rodent burrows visible; need to backfill and compact or grout burrows.	39.261403 ° -121.636660 °	39.261403 ° -121.636660 °	5 Y
DWR ID: DWR_MA0016_01_s_2012_5									
7	0.45	0.49	Earthen Levee	Encroachments	LS U En	BU : Buildings	39.262213 ° -121.636545 °	39.262825 ° -121.636430 °	7 Y
DWR ID: DWR_MA0016_01_s_2012_7									
8	1.14	1.14	Earthen Levee	Encroachments	WS C Ma	MA : Material	39.272128 ° -121.633730 °	39.272128 ° -121.633730 °	152
DWR ID: DWR_MA0016_01_s_2012_152									
9	2.85	3.08	Earthen Levee	Encroachments	LS M En	AD : Agricultural Ditch	39.293675 ° -121.636615 °	39.296748 ° -121.638192 °	14 Y

Levee mile 0.10. This photo shows the landscaping on the landside slope and toe.

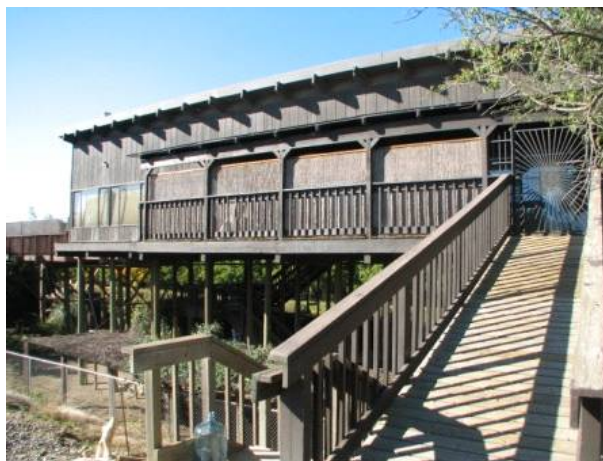
Levee Mile Report Line	5
Start Levee Mile	0.18
End Levee Mile	0.18
Location	Land Side
Category	Earthen Levee
Item	Encroachments

Levee mile 0.18. This photo shows the building on the landside shoulder and toe.

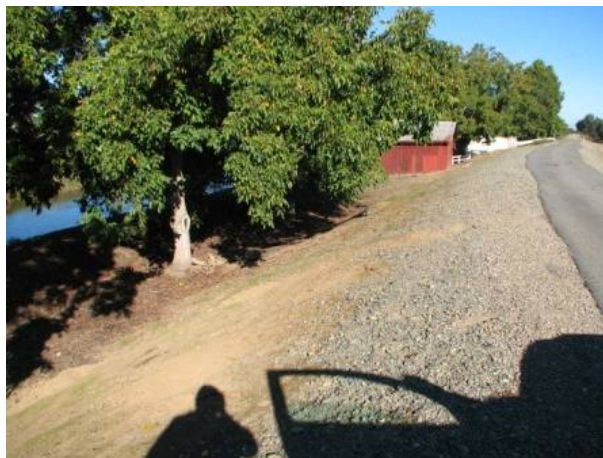
Levee Mile Report Line	6
Start Levee Mile	0.39
End Levee Mile	0.39
Location	Land Side
Category	Earthen Levee
Item	Animal Control

Levee mile 0.39. View of squirrel hole along the slope.

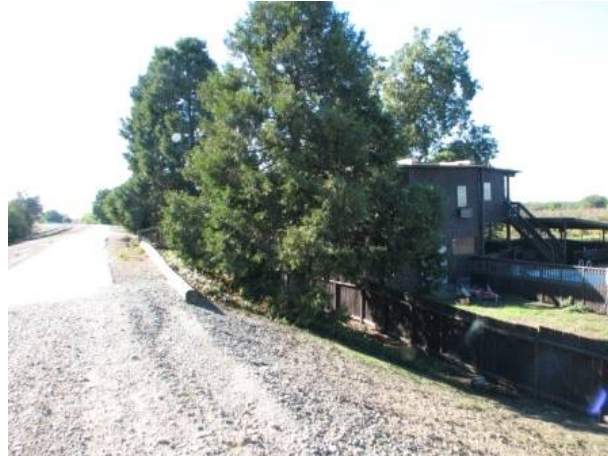
Levee Mile Report Line	7
Start Levee Mile	0.45
End Levee Mile	0.49
Location	Land Side
Category	Earthen Levee
Item	Encroachments

Levee mile 0.49. This photo shows the building and landscaping on the landside slope and toe.

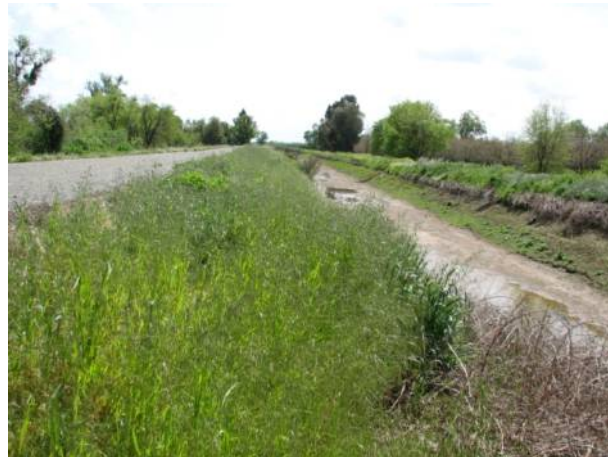
Levee Mile Report Line	9
Start Levee Mile	2.85
End Levee Mile	3.08
Location	Land Side
Category	Earthen Levee
Item	Encroachments

Land side ditch levee mile 3.08.
